## Case Report

# Vaginal Extrusion of Transobturator Tape 6 Years after Procedure: How Long Should Be the Follow-Up Period after Vaginal Sling Surgeries?

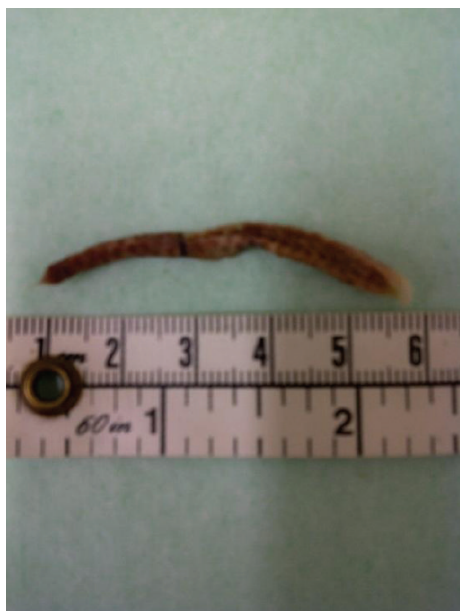
hysterectomy with pelvic floor repair and transobturator tape insertion (TOT) for third degree uterovaginal prolapse and USI 6 years ago at our institution. The tape used was Obtape (Mentor-Porges, Le Plessis-Robinson, France). She had no hesitancy, stress, or urge incontinence and was able to empty the bladder completely at one-year followup after surgery. She defaulted further followup but had been asymptomatic until current presentation. She was sexually inactive for the last 8 years. She had no history of diabetes. Her BMI was 22. General physical examination was unremarkable and abdomen was soft. There was no evidence of sepsis or cellulitis. There was no cystocele, rectocele, enterocele, or vault prolapse. On speculum examination there was foul smelling discharge. A light green braided suture about 2-3 cm was seen protruding from the middle of the vault surrounded by granulation tissue. The suture was held with an artery forceps and cut at its base. This was a loop remnant of Ethibond number 1 suture used for McCall’s culdoplasty during vaginal hysterectomy. On vaginal examination, a 4 to 5 cm tape segment was felt protruding through the vagina in the midurethral region. During the digital examination of the tape extrusion, it literally came off the vagina (Figure 1). There was no tenderness on examination. A vaginal swab

FIGURE 1: The spontaneously extruded transobturator tape (TOT).

was sent for culture and antibiotic pessary was prescribed for 7 days. Urine microscopy and culture were negative. She was reviewed in the clinic 2 weeks and 6 weeks later. Her discharge resolved completely. She continues to be asymptomatic and has no complaint of urinary incontinence. The vaginal swab culture was reported as mixed bacterial growth.

Management depends on the site of erosion, its extent, severity of symptoms, and the type of tape used. Vaginal erosions are associated with less morbidity as compared to urethral or bladder erosions. Most authors recommend surgical removal of the mesh [3] especially if it is not a type I tape, that is, if it is a nonwoven thermally bonded polypropylene mesh like Uratape (type IV) or Obtape (type II). Such tape erosions should be treated by immediate and maximal tape removal to prevent life-threatening infections like obturator abscess and perineal cellulitis [2–4]. If there is extrusion of a type I tape in the lateral vaginal sulcus causing dyspareunia, it can be excised in the outpatient setting under local anaesthesia. An asymptomatic tape extrusion in an elderly lady who is not sexually active may be treated conservatively. Vaginal oestrogen may be prescribed in case of atrophic vaginitis. If there are signs of infection, vaginal or oral antibiotics should be prescribed. Partial removal of only the extruded part of a type I tape may prevent recurrence of stress urinary incontinence.
